**IPEM GISP working party update**

Sarah Prescott<sup>1</sup> on behalf of the IPEM MR-SIG working party on generic implant safety procedures

# Safety Benefits of an Advanced Acceleration Technology and an Implant Interface in Scanning a Complex MR Conditional Implant

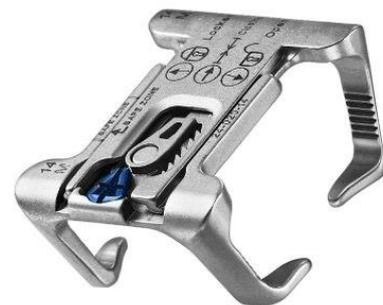
Figure 1: KLS Martin Sternal Talon

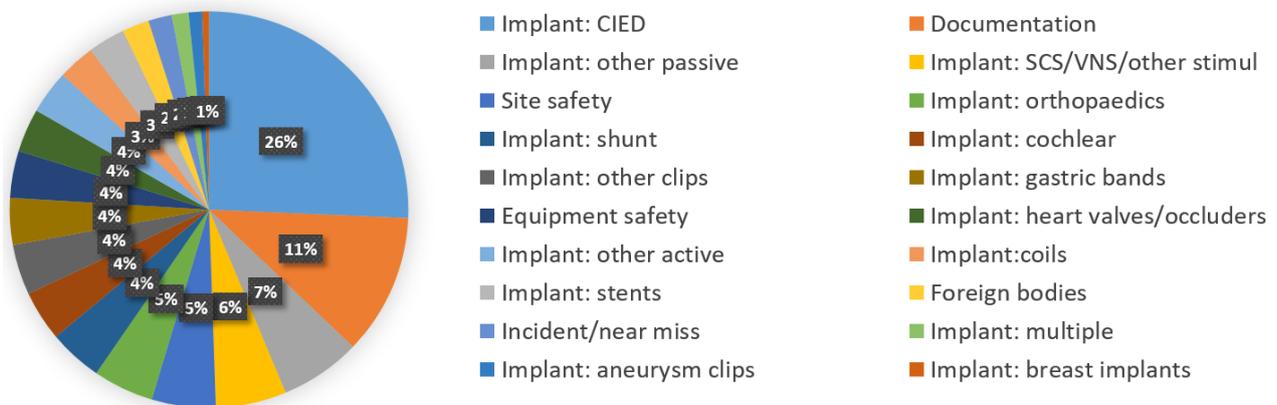
**Fig 1: Safety queries (Aug 2020-Jul 2023)**

**Methods.** All safety queries submitted to the ticketing system were queried and classified according to the predefined logging categories (Fig 1). The cardiac implantable electronic devices (CIED) queries were then further divided according to the MRI status of the device (MR Conditional vs not MR Conditional, so off label required for scanning) and plotted over time. Two key local events in the timeline (the approval of a set of MR Conditional CIED checklists, and the approval of an off label CIED MR Protocol) were also marked in the timeline graph (Fig 2).

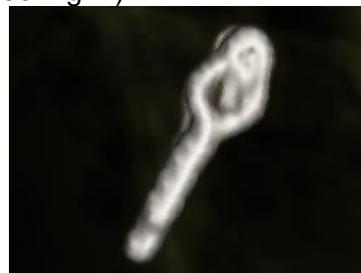
(a) CT scout

(b) Helical CT 3D reconstruction

**Results:** CMPE have incorporated 3D CT reconstructions into their safety checking process, providing strong assurance of the clip model. Two patients have been scanned successfully using this procedure with no adverse incidents. The first patient had an implant date of 2000 and the second of 2003. For both patients we were able to conclude with a high degree of confidence, that the clips were non-ferrous Yasargil clips. For an upcoming patient we were able to conclude, with a high degree of confidence, that the clip is a non-ferrous Yasargil/ Sugita clip (implanted 1996). The most likely model is believed to be a Sugita Straight (L) aneurysm clip (see Fig. 1).
